Special Investigations and Prosecutions Unit

Report on the Investigation into The Death of Susan LoTempio

Barbara D. Underwood
NYS Attorney General

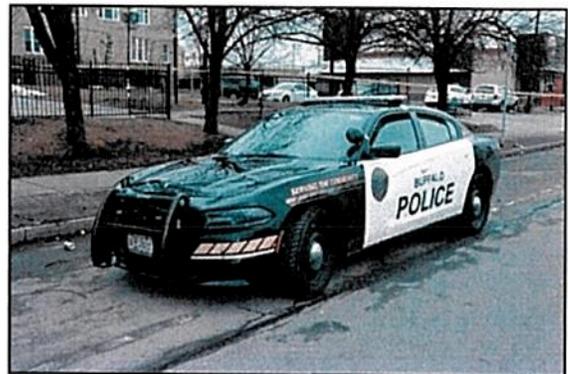
Registration State:	New York
Registration Number:	D-639
VIN:	2C3CDXKT7GH333730
Year:	2016
Make:	Dodge
Model:	Charger – Police Interceptor
Color:	Black & White
Odometer:	39,536
Inspection:	1170293
	Expires: 01/31/2019

The exterior showed an area of cleaning and a fabric impression on the lower bumper cowl directly beneath the front license plate. Another area of cleaning was found on the bottom of the front license plate bracket. The push bumper was found to have been pushed rearward on the right (passenger) side and driven into the area just above the grille. An LED (light emitting diode) that was mounted on the right side of the push bar was slightly bent rearward and found not to be working properly. A dent and an area of cleaning were noted to the leading edge of the engine hood, just to the right of center. There were several areas of cleaning that were found on the engine hood, mostly just left of center, that led to damage located at the trailing edge of the engine hood and at the bottom of the windshield. An apparent strand of human hair was noted amid this damage. Bodily fluid was also noted on the center of the windshield, just above this damage. Although the roof and emergency lighting mounted on the top of Vehicle 1 appeared pristine, there was a significant amount of apparent human blood that was noted to the rear window on the left side, the "C" pillar on the left side and the trunk lid on the left side of the vehicle. A small amount of apparent human blood was also found on the left rear passenger door of Vehicle 1.

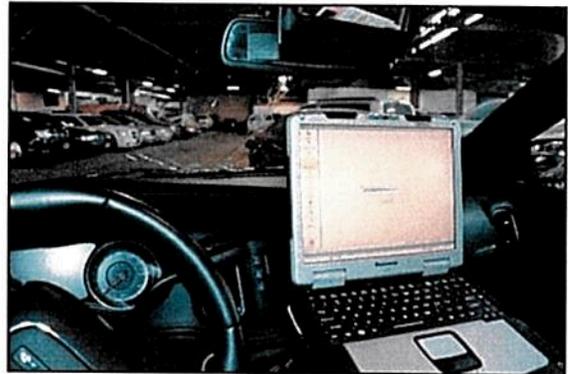
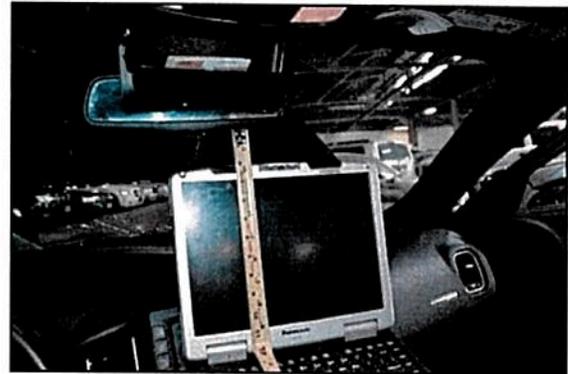
* When this computer screen was open and vertical, I found it to consist of a bright white lighted background.

* When this computer screen was open and vertical, there was approximately 1.5 inches of a viewable area available (from a driver's vantage point) between the top of the computer screen and the bottom right half of the mounted rearview mirror.

* When this computer screen was open and vertical, its protrusion obstructed approximately 3 inches into the viewable area (from a driver's vantage point) from the bottom of the windshield to the top of the computer screen.

The placement of the MCT in PO Ahearn’s car obstructed a portion of his view of the side of the road on which Ms. LoTempio was walking. While changing the placement of the MCT may not have prevented this accident, we recommend that BPD explore changing the placement of the MCT so as not to obstruct the driver’s view.¹²

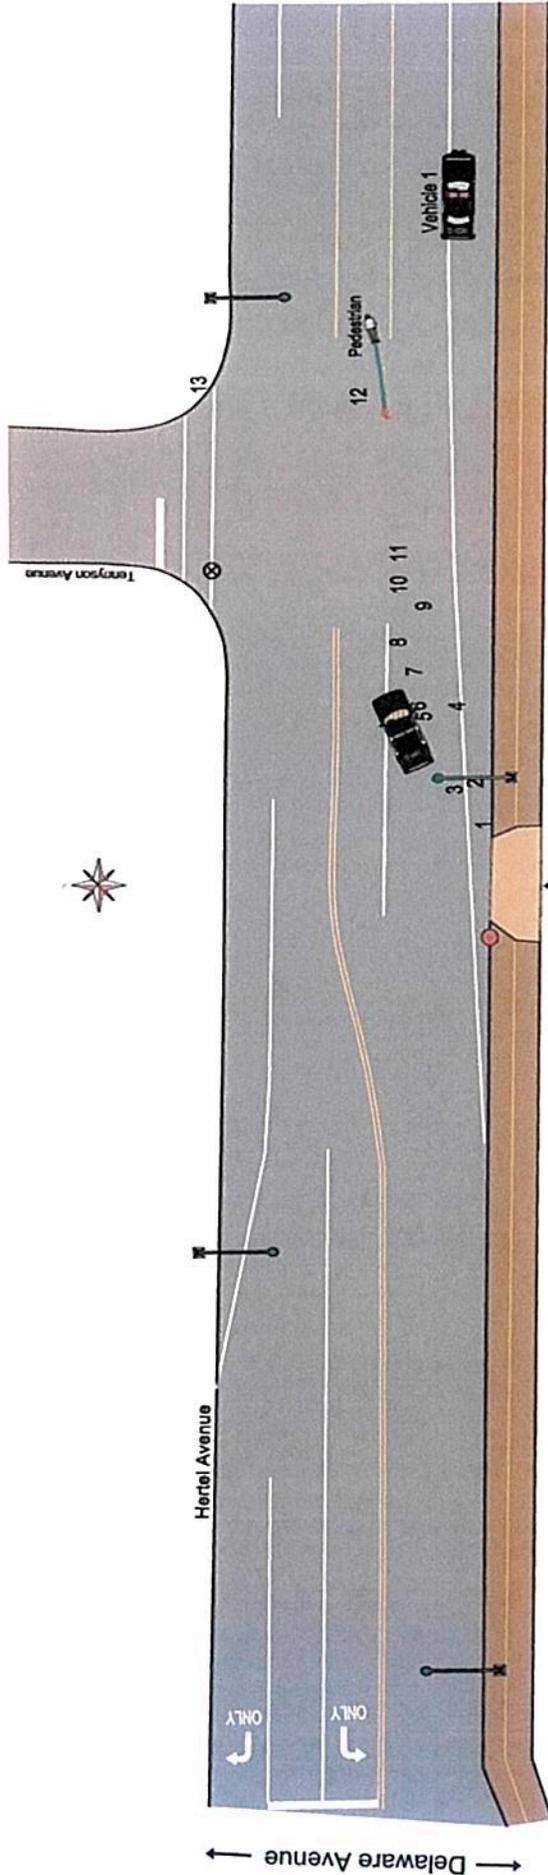
Proceeding easterly through the collision scene, the first evidence noted was a left glove. This glove was black in color and was found on the south shoulder of the roadway against the curb.

Next, a broken piece of eyeglass lens was noted, which was also found on the south shoulder of Hertel Avenue between the fog line and the curb. This broken piece of eyeglass lens was located approximately 8 feet 10 inches east of the left glove.

An eyeglass lens was noted next. This eyeglass lens was found in the eastbound lane of the roadway approximately 2 feet 8 inches north of the fog line.

A sock was noted next. This sock was found in the eastbound lane of the roadway approximately 1 foot 2 inches north of the fog line. It was located approximately 17 feet 1 inch east of the eyeglass lens.

A soda can box was noted next. This box was located in the eastbound lane of the roadway. It was found lying beneath the passenger side running board of the previously mentioned Chevrolet Tahoe.

A right glove, that matched the previously mentioned left glove, was found next, just east of the soda can box.

Three broken pieces of eyeglass lens were noted next, all of which were located near the center of the eastbound lane.

Amid the three broken pieces of eyeglass lens was a grey knit hat.

A right boot was noted next. This boot was black in color and was located approximately 18 feet 6 inches east of the grey knit hat.

A “Dodge” grille emblem was noted. This emblem was found in the center of the roadway near the west end of the center turning lane.

Lastly, a left boot, that matched the previously mentioned right boot, was noted. This boot was located on the northeast corner of Hertel and Tennyson Avenues.
