**Report on the Investigation into  
The Death of Warren Corbitt**

**Division Vehicle/Motorcycle Fatal Injury Collision  
Amended Report**

**State Route 82  
Town of Washington  
Dutchess County**

**Troop K  
Collision Reconstruction Unit**

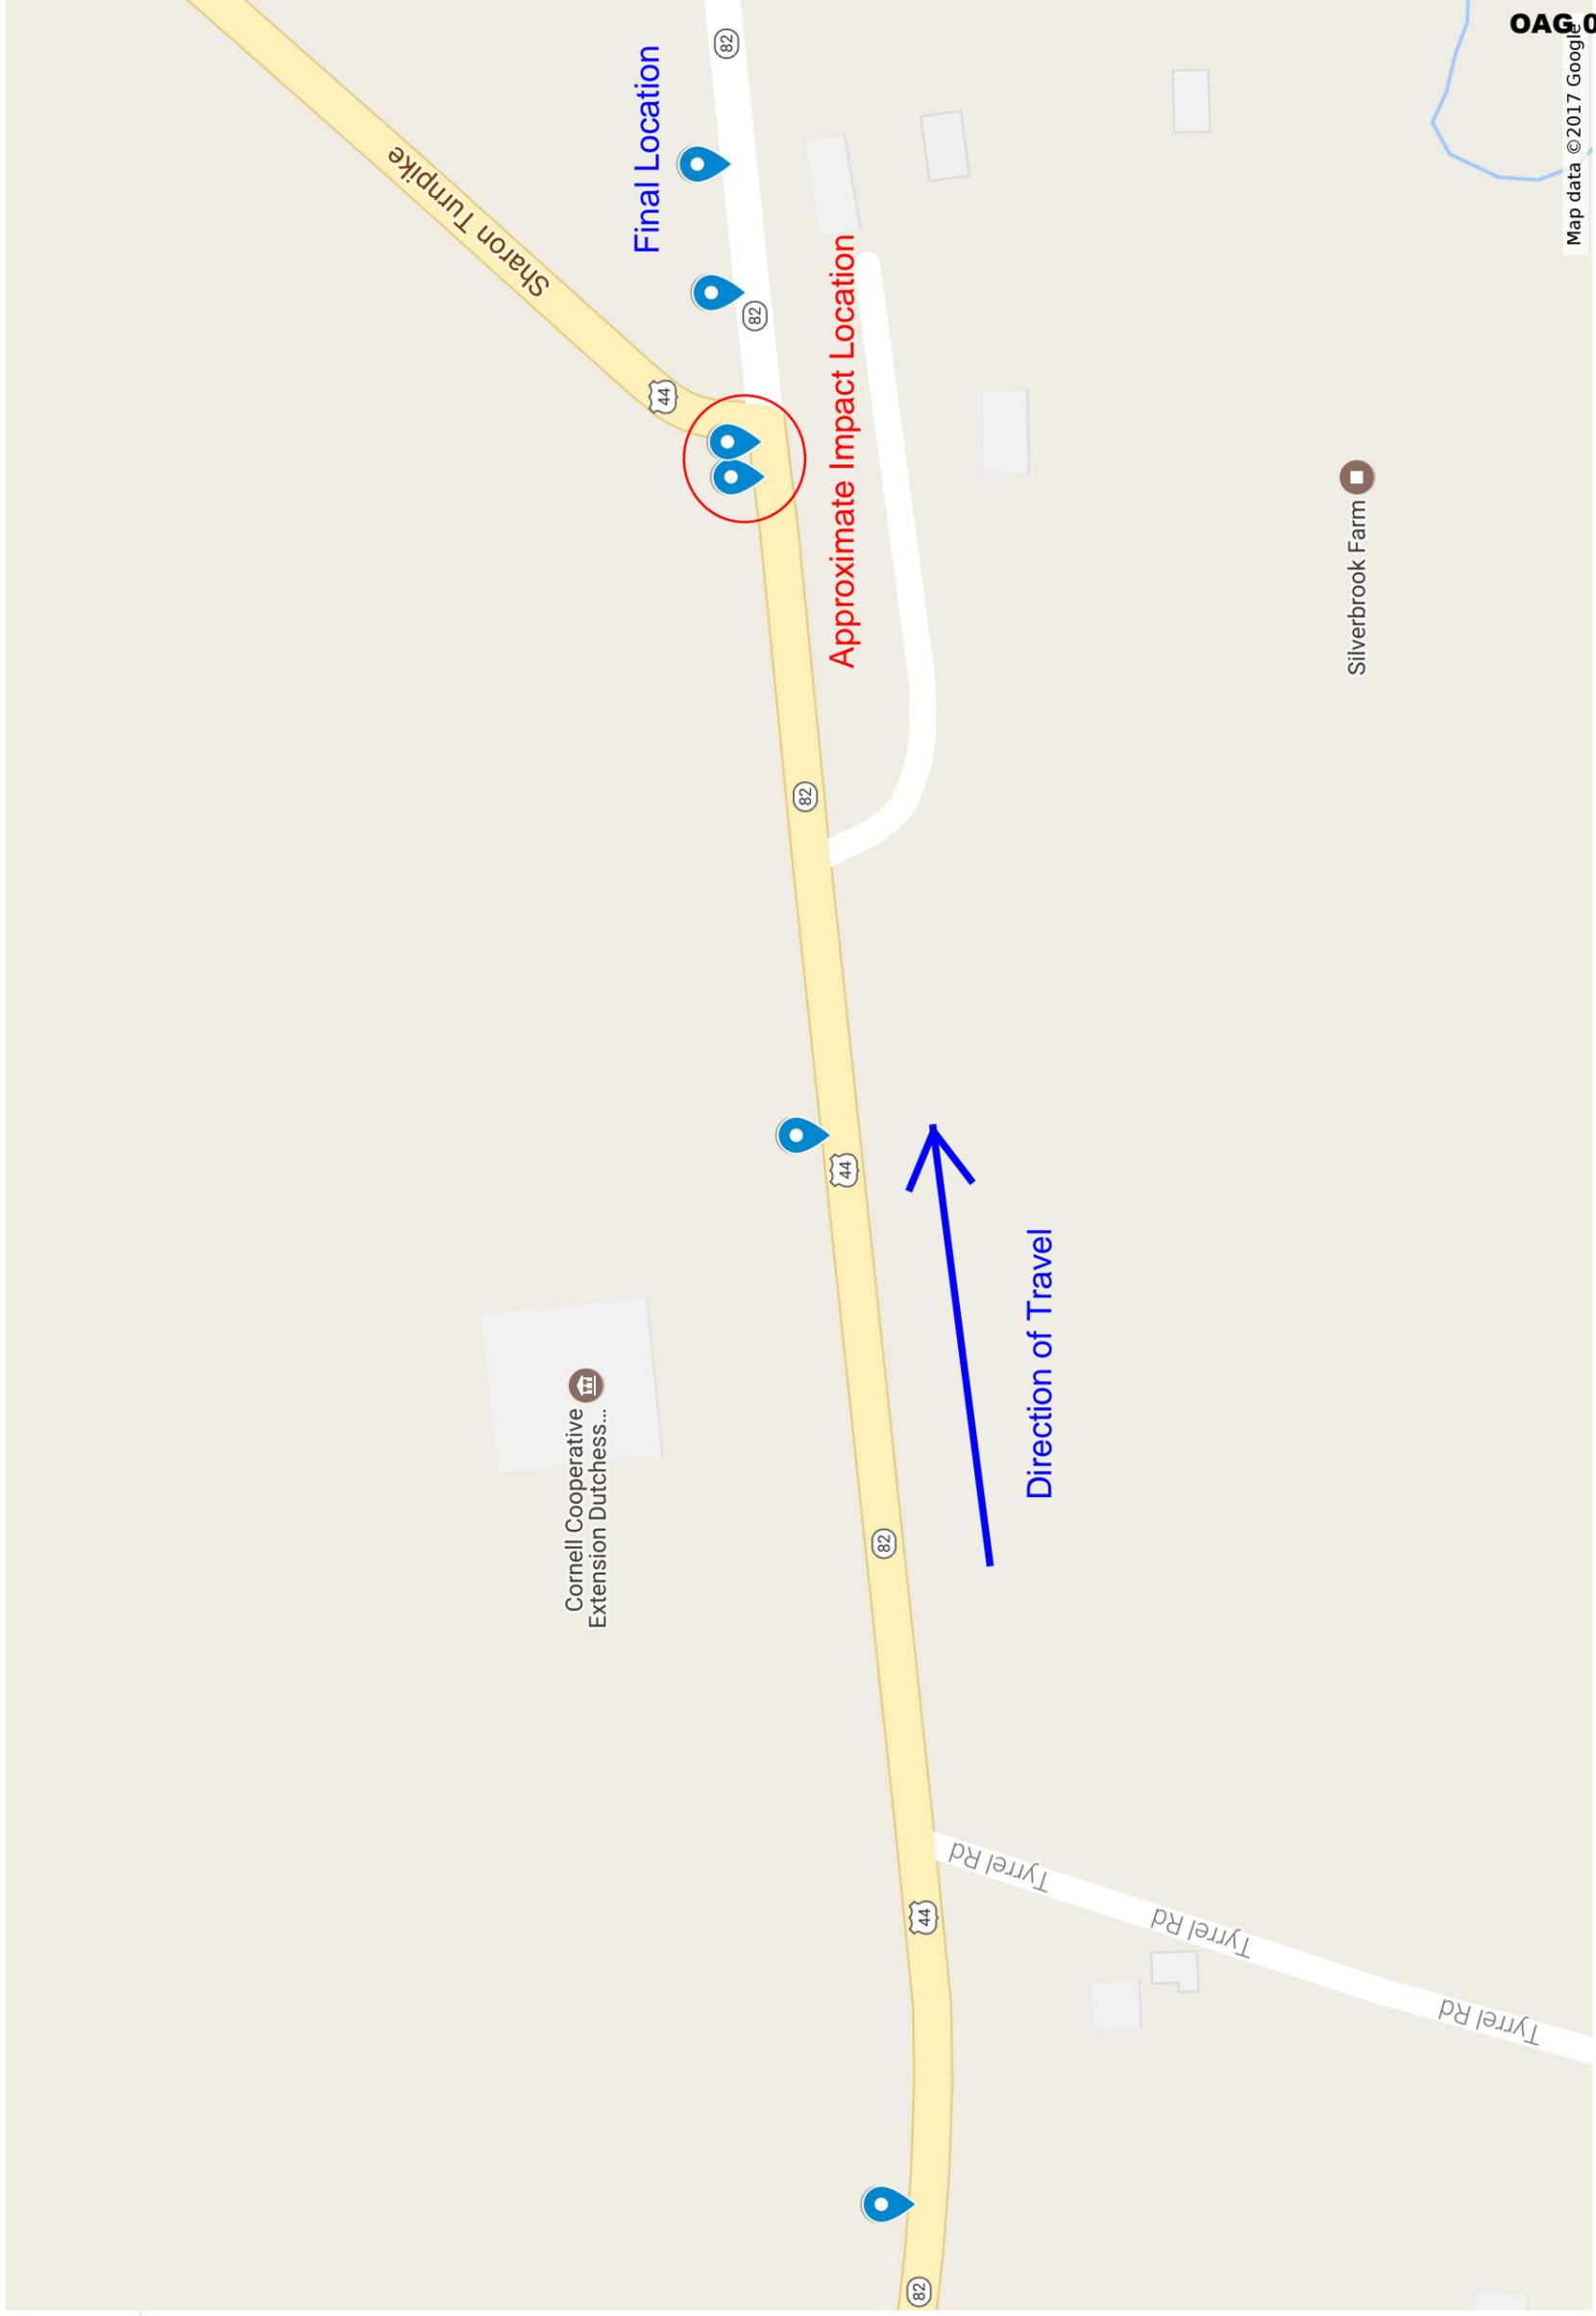
# Accident Area

<sup>1</sup> A diagram of the general area of the accident is attached hereto as Exhibit 1. As depicted on the diagram, the collision took place where Route 82 and U.S. 44 separate. Route 82 continues in a straight path from the combined Route 82/U.S. 44. To continue on U.S. 44, a motorist in the eastbound lane must turn left.

Motorcycle GPS Path Data

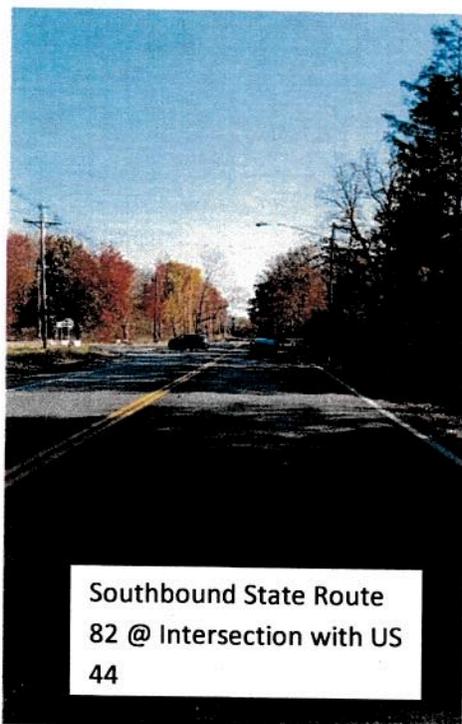
New York State Route 82 (State Route 82) and US Route 44 (US 44) run concurrently in the area prior to the collision scene. In the area of the collision, US Route 44 changes direction and travels north creating the eastern intersection of State Route 82 and US 44.

New York State Route 82 (and US 44) was a two-way, two-lane roadway constructed of asphalt that traveled in a general north – south direction. In the area of the collision, however, due to the layout of the roadway and permanent landmarks, State Route 82 travels in a true east – west direction, and will be described as such. State Route 82 travels straight through the intersection. The roadway was divided by double-yellow lane lines, and solid white lane lines in the area of the shoulders. The shoulder of the eastbound lane of State Route 82 measured approximately 1.73 feet in width. The eastbound lane of State Route 82 measured approximately 17.6 feet in width, measured from the middle of the center line to the white fog line. The

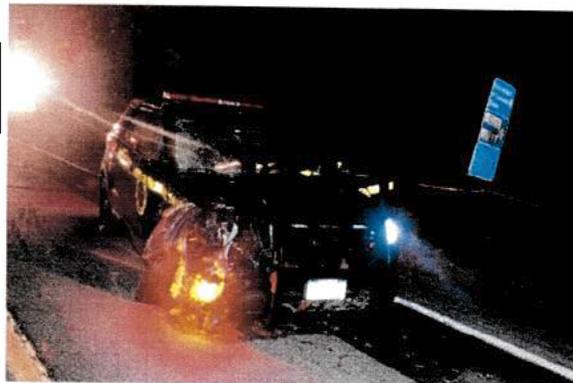
**VEHICLE EXAMINATIONS:**Vehicle #1

There was contact damage to the passenger side front corner, passenger side fender, hood, passenger side headlamp assembly, passenger side front tire and rim, windshield, roof, passenger side mirror and spotlight. Induced damage to Vehicle #1 included the passenger side front door and the interior.

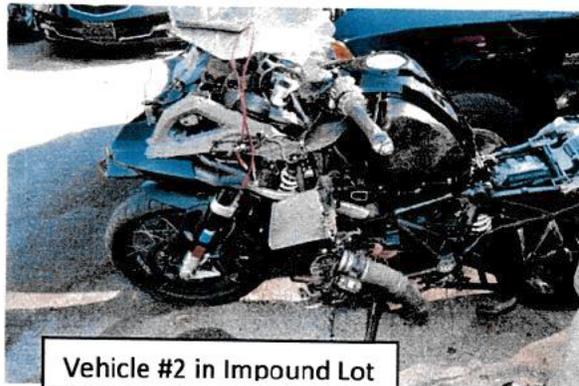
There was contact damage to the left side of Vehicle #2 including the faring, wind screen, left side molding, the variable top box, left side frame and left foot peg. The damage to the left side is from contact with Vehicle #1 and from the roadway as it slid to its position of final rest.

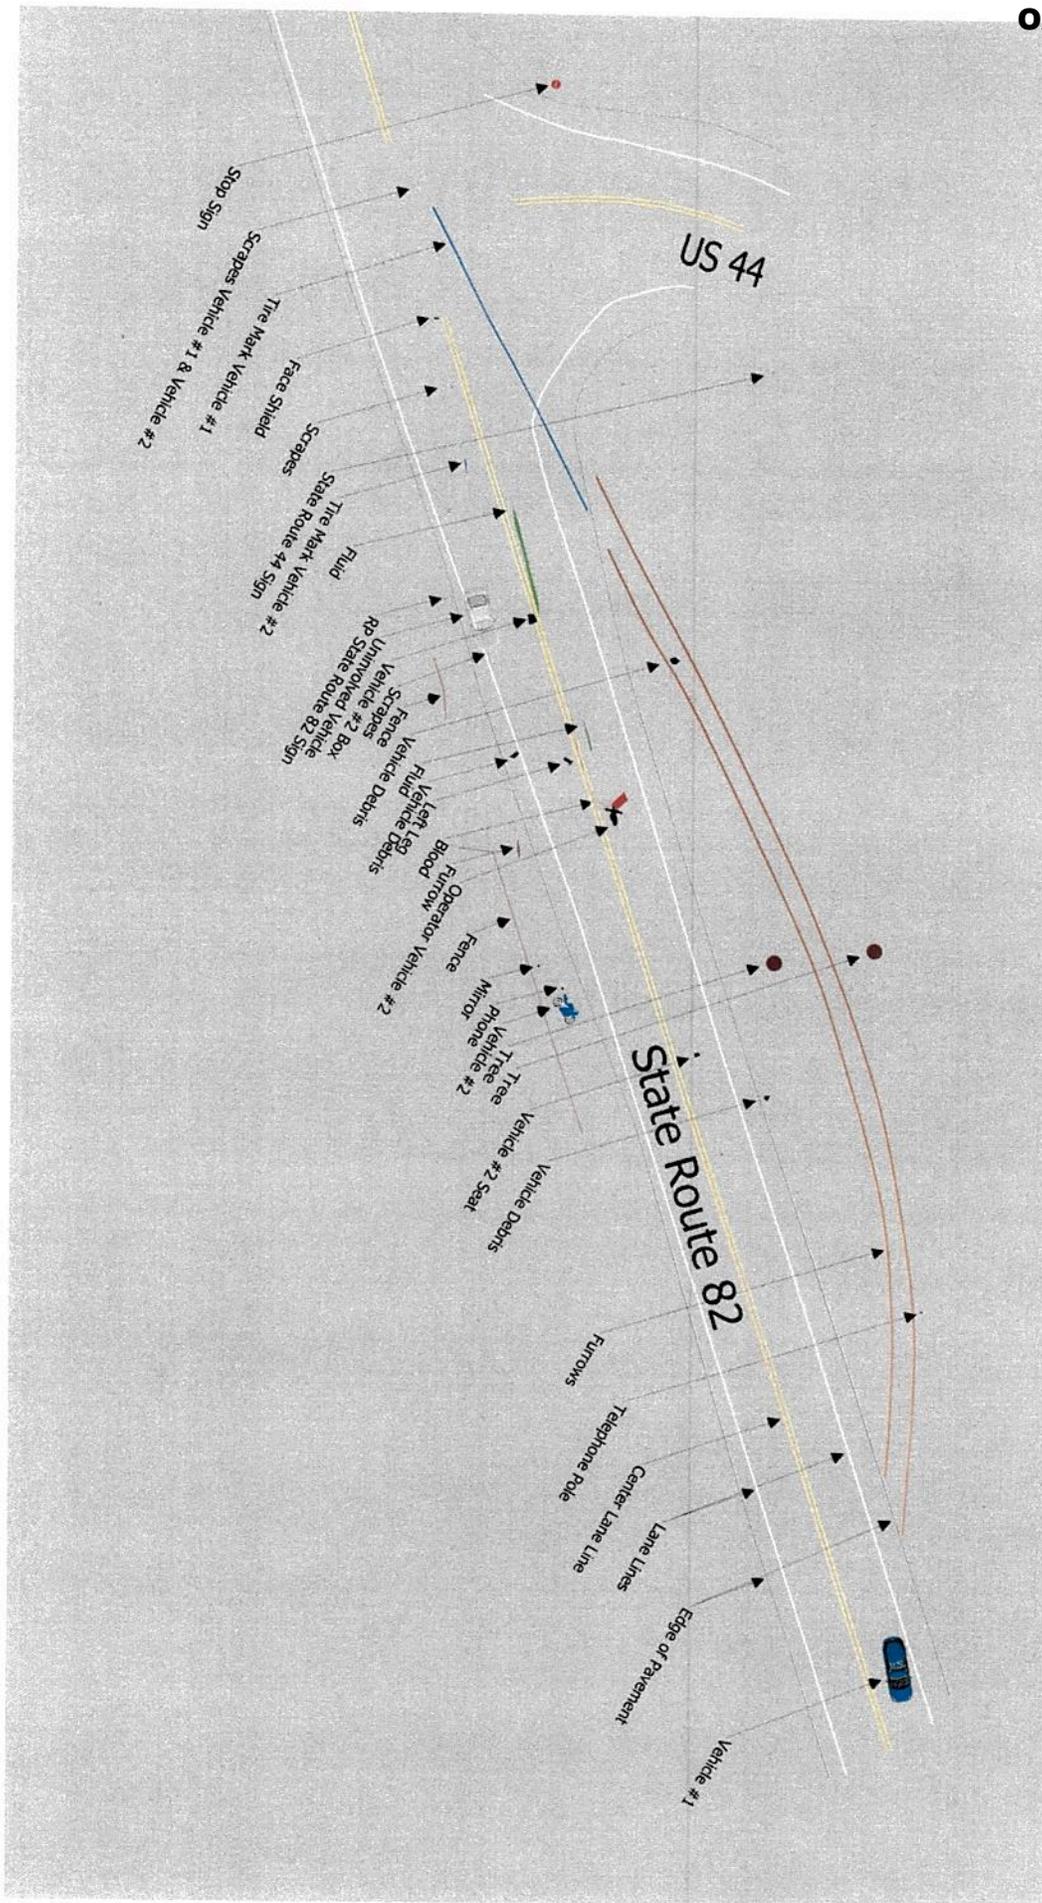
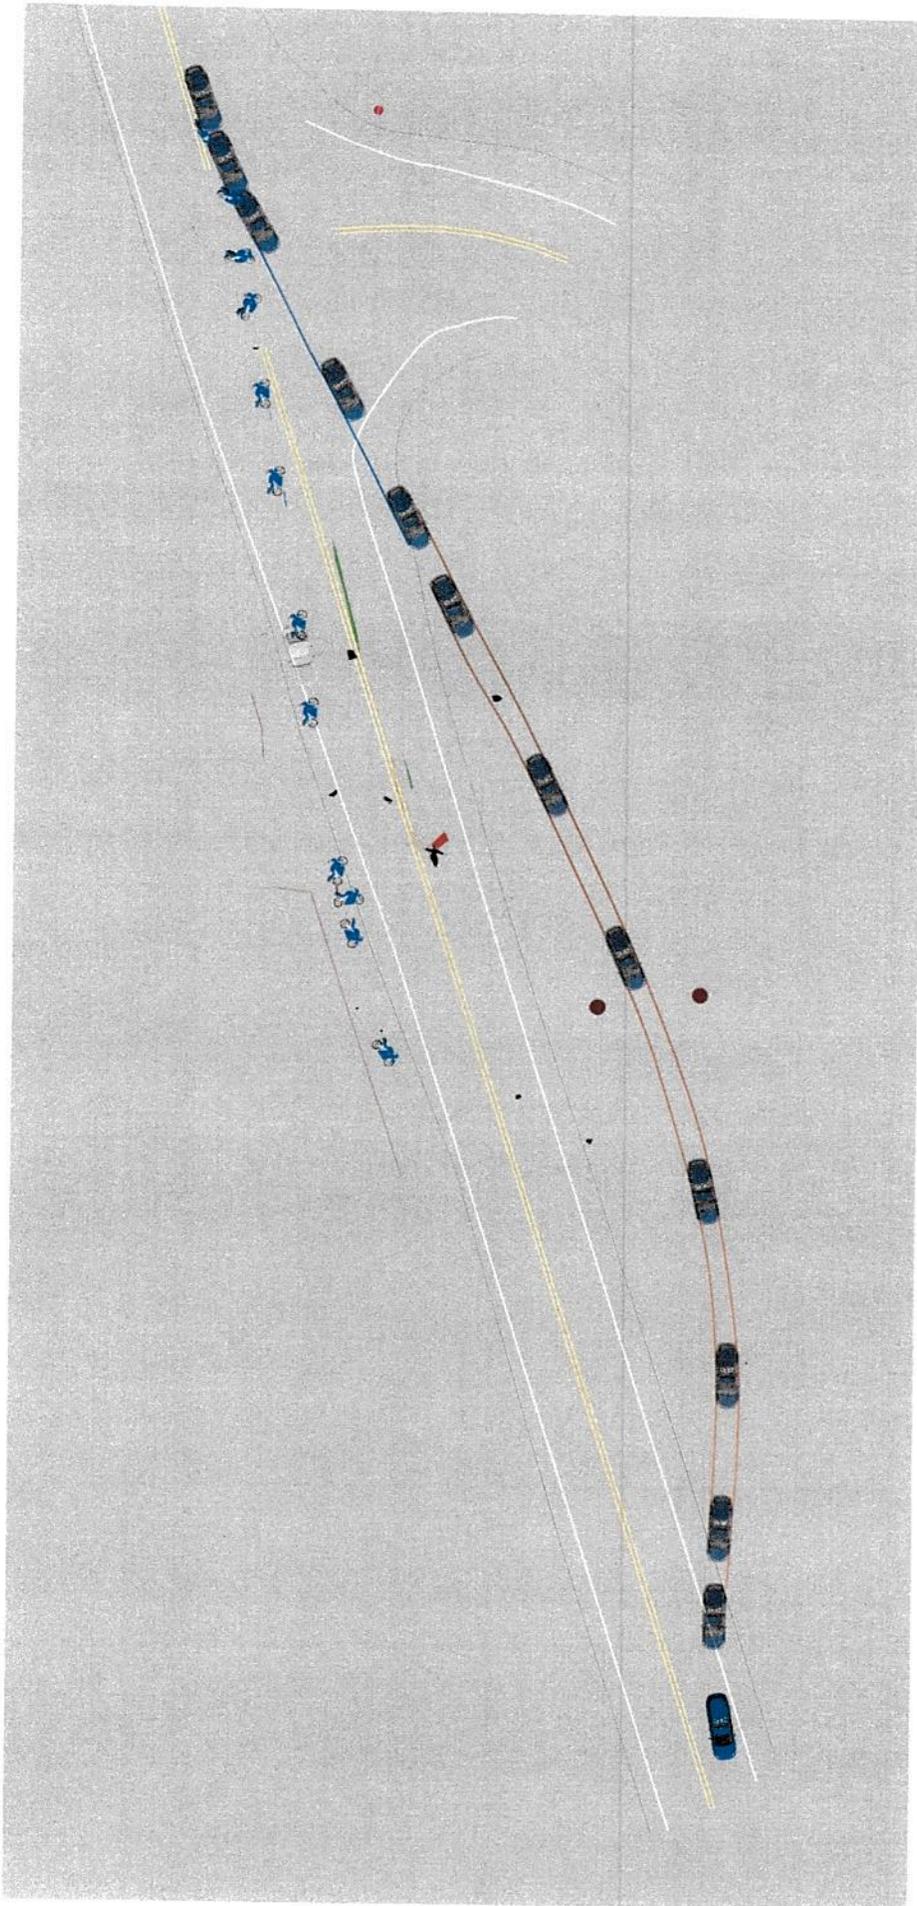
<sup>2</sup> A diagram of the roadway and the collision in the collision reconstruction report is attached hereto as Exhibit 2. As depicted in the diagram it appears that Mr. Corbitt was attempting to turn left onto U.S. 44.

the eastbound lane of State Route 82 and onto the south shoulder to its position of uncontrolled final rest, facing east. The uninvolved vehicle pulled onto the south shoulder of State Route 82.
