**Report on the Investigation into
The Death of Lillian Weyanna**

Monroe County Sheriff's Office Motor Vehicle Collision Investigation Supplemental Report

CR #18-216618
TraCS # FPZC419098ML
Date of collision: December 8, 2018
Location of collision: Ridge Road east of Trimmer Road, Town of Parma
Reporting Officer: Trevor Ott
Scene measured by: Schillaci and McCoy
Measuring instrument: Leica Total Station

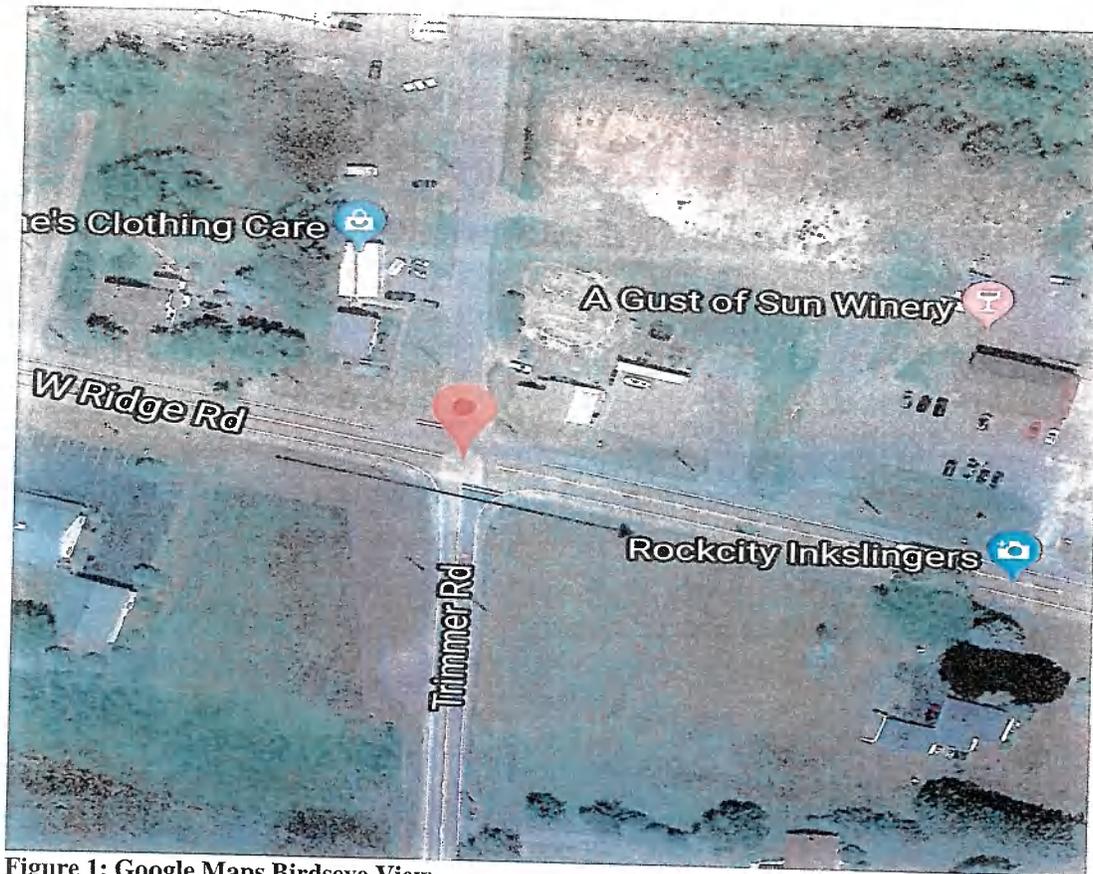
Figure 1: Google Maps Birdseye View.

The incident occurred on Ridge Road in the Town of Parma immediately east of the intersection of Ridge Road and Trimmer Road nearest to Reference Marker 104 4303 1093. Ridge Road was a designated east-west, two lane and undivided highway. This was a posted 55 MPH zone. The paved material was asphalt and its condition was considered to be "travelled". Travelled asphalt is a condition type of the pavement between newly paved and traffic polished. The surface in this area maintained a residue that appeared to have been the result of a previous salting of Ridge Road. The entire roadway from the north edge of the paved portion to the south edge of the paved portion was in good condition. Ridge Road in this section was clearly marked with two solid white fog lines and a centerline which permitted passing for eastbound traffic and prohibited passing for westbound traffic. Beyond the paved edge to the south was a snow covered grassy area. The north side of the road was snow covered grassy areas broken by driveways. The area of the incident was straight and level.

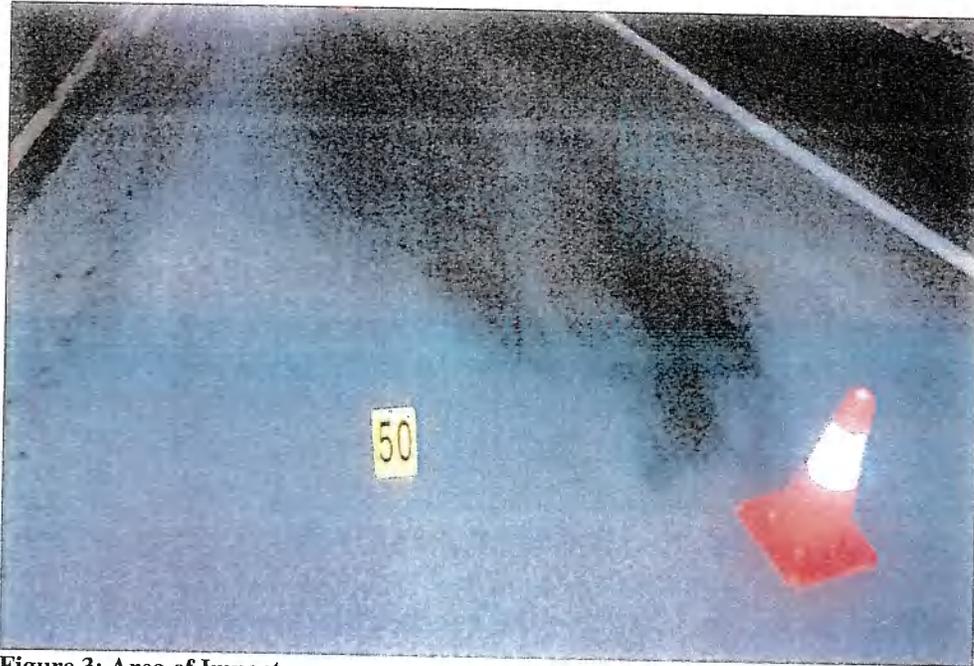
Figure 3: Area of Impact

Evidence at the scene originated in the area of impact and created a debris pattern in the eastern direction toward the deceased pedestrian and beyond. A widening spill pattern was the primary indication determining the area of impact. The debris pattern was scattered with pieces of blue glass indicating that the liquid causing the spill had originated from a glass bottle being transported by the deceased.

Additional evidence which supported the area of impact was a paper bag that was stuck in the grill of Vehicle 1. The orange colored paper bag perished during the transportation of the vehicle, however there are photographs illustrating its existence. Additionally there was a faint tire mark in the eastbound lane just east of the spill that continues east for approximately 153 feet. The tire mark maintains a generally straight eastbound direction and fades until it can't be seen. The tire mark was two faint tire marks; the rear driver side tire mark over the top of the front driver side tire mark. Vehicle 1 was subsequently moved by the driver to the south road edge of Ridge Road just west of the deceased. The deceased was located approximately 130 feet east of the area of impact in the snow adjacent to the south shoulder of Ridge Road.

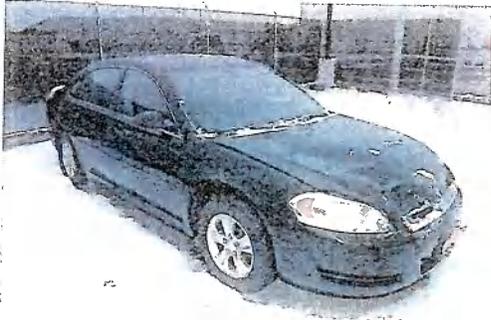
Figure 4

Collision damage to Vehicle 1 came from one impact. Collision damage is described as contact damage and induced damage. Contact damage is the result of vehicle parts being directly contacted by another vehicle, another object, the ground or occupant(s). Contact damage was observed to the front end and the hood. The pedestrian

made contact with Vehicle 1 at the plastic bumper to the passenger side of the license plate. The plastic air intake grille was also broken into pieces. The pedestrian maintained contact with the vehicle which caused damage from the impact point of origin to where her head struck the hood. This trenched damage shape was consistent with the stature of the pedestrian.

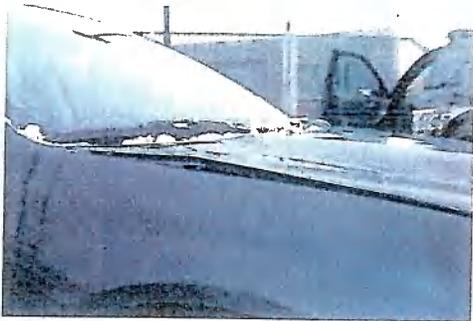
Figure 6

Induced damage results from the collision forces collapsing, twisting or bending the vehicle or its parts; it is a non-contact form of damage. Induced damage is observed to the hood on both the passenger side and driver side edges. The damage was a rippling effect that is caused by the contact damage pushing downward near the hood's middle portion.

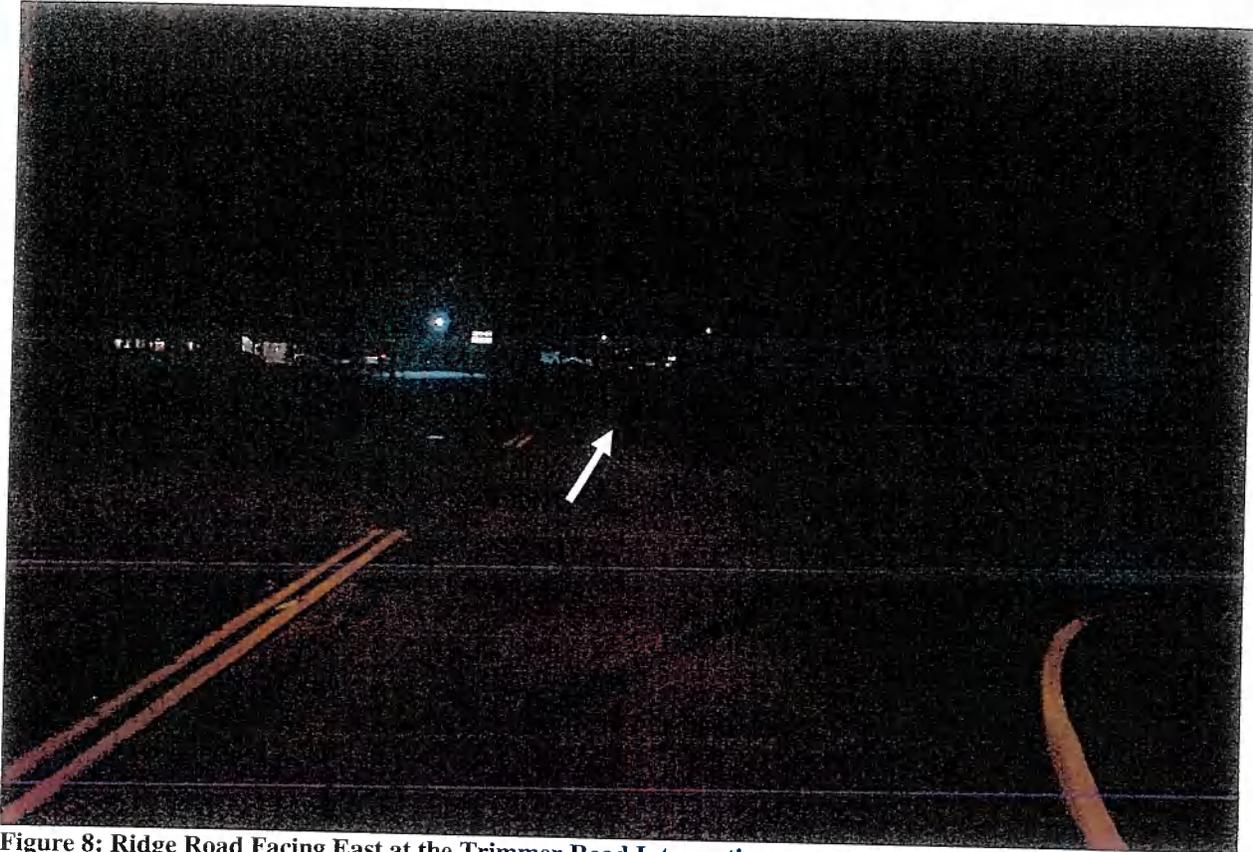
Figure 8: Ridge Road Facing East at the Trimmer Road Intersection

Prior to the collision the Chevrolet was traveling east on Ridge Road in the eastbound lane. There was no evidence of evasive maneuvers or markings prior to impact. During its travel eastbound Vehicle 1 entered the semi-lit intersection of Ridge Road and Trimmer Road. The street lamp illuminated the immediate area underneath it. The area east of the light on Ridge Road appeared dark and un-lit when looking through the illuminated area of the intersection. The pedestrian was attired in all black clothing. Referencing the photograph below, the area of impact is within the dark portion east of the intersection.
