Office of the New York State Attorney General Letitia James  
Office of Special Investigation

# Report on the Investigation into the Death of Amos Domfeh

## Summary

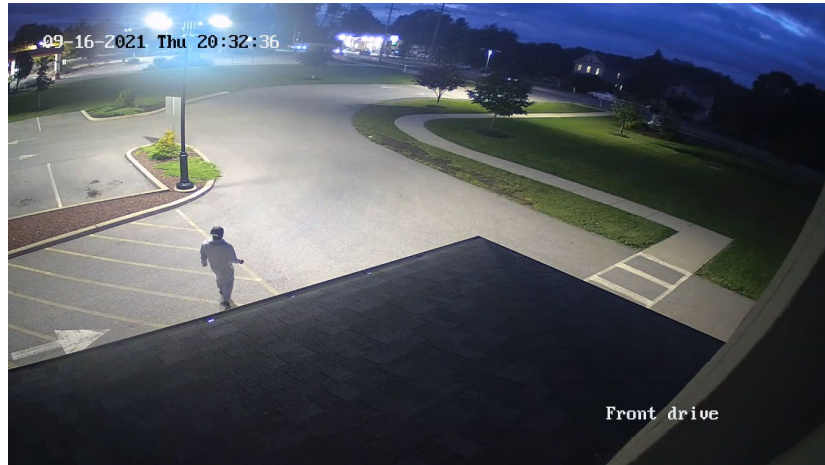
*Still from the security camera footage showing Mr. Domfeh leaving the facility*

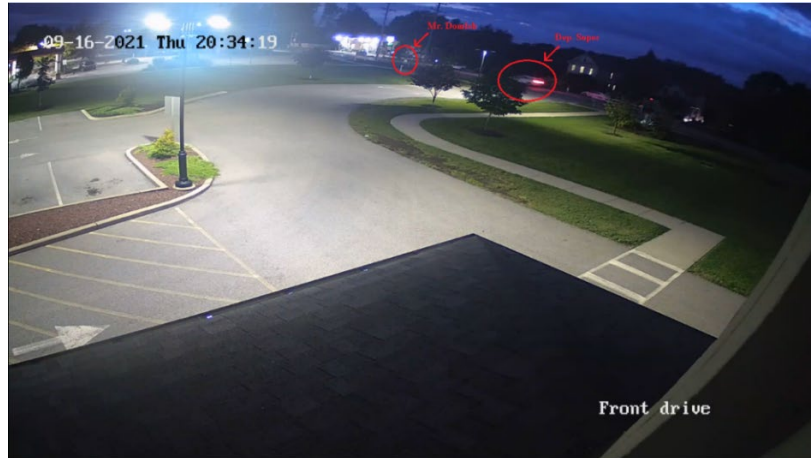
The footage momentarily stops at 7:33 p.m. and resumes a minute later,<sup>4</sup> at which point the footage shows Mr. Domfeh crossing Violet Ave at a section of road that does not have a crosswalk, traffic light, or streetlight, according to the scene photographs and the report of the New York State Police (NYSP) accident reconstructionist, discussed below. He was halfway across the road and starting to cross the southbound lane of travel when a marked police SUV, driven by Dep. Super, approached in the southbound lane with the headlights on and the emergency lights off. The still below shows the distance separating Mr. Domfeh and Dep. Super at the point the footage resumed.

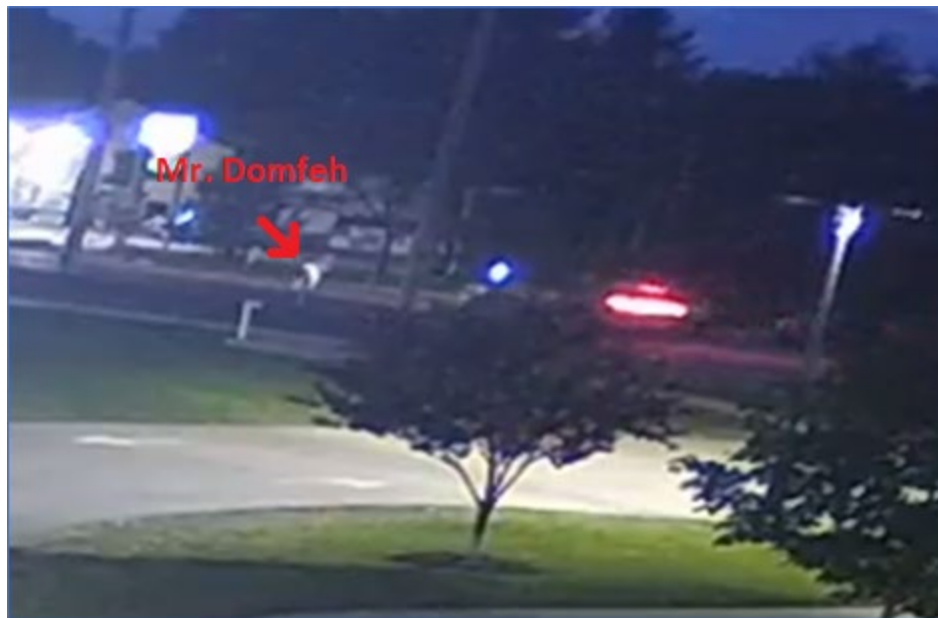
The footage shows Mr. Domfeh continued to walk across the southbound lane without changing pace or direction as the SUV drew closer. A half second before impact, with about 30 to 40 feet between the SUV and Mr. Domfeh, the SUV's brake light activated, suggesting Dep. Super saw Mr. Domfeh in the road and was applying the brake to avoid a collision. Mr. Domfeh appeared to be near the center of southbound lane at the time of impact. The force of the collision lifted Mr. Domfeh off the ground and propelled him forward to the gas station parking lot where he came to rest near a gas pump. After striking Mr. Domfeh, Dep. Super's SUV swerved into the northbound lane, which caused a passing car to drive onto the shoulder to avoid a collision. The SUV quickly turned back into the southbound lane and parked in the gas station parking lot. A link to the video footage is here: [surveillance video](#).

*Still showing the position of Mr. Domfeh and the SUV the moment the brake light was activated.*

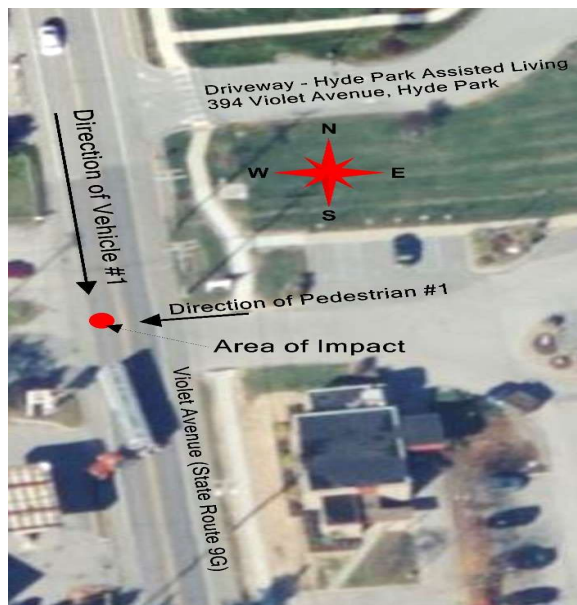
*Map showing the area of the collision.*

Investigator Peter Maczkiewicz, of NYSP's Collision Reconstruction Unit (CRU), responded the night of the incident and processed the scene along with other members of the unit. Inv. Maczkiewicz, an accident reconstructionist certified by the Accreditation Commission for Traffic Accident Reconstruction, performed a Motor Vehicle Collision Investigation and Analysis and issued a report (Reconstruction Report).

Inv. Maczkiewicz told OSI that the unit collected and documented the physical evidence at the scene, which included a white scuff mark in the middle of the southbound lane, SUV debris south of the scuff mark, damage to the SUV's passenger side front end, and, on the side of the road north of the gas station, Mr. Domfeh's hat and left shoe alongside flattened campaign signs.

Inv. Maczkiewicz said that after looking at the physical evidence and comparing the sole of Mr. Domfeh's left shoe to the white scuff mark, he determined that Mr. Domfeh was standing at the location of the scuff mark when he was hit by the Durango. He said the force of the collision caused Mr. Domfeh's foot to scrape across the ground. Due to the flat front end of the Durango, he said Mr. Domfeh traveled through the air at relatively flat trajectory, hit the curb, and then continued another few feet until he came to rest in the parking lot. He based Mr. Domfeh's trajectory of travel on the flattened campaign signs, the location of the hat and shoes, and where his body came to rest. Having established the area of impact and Mr. Domfeh's path of travel, Inv. Maczkiewicz next measured from the scuff mark to the location where Mr. Domfeh was treated by EMS and determined he had been thrown 65 feet by the force of the collision.

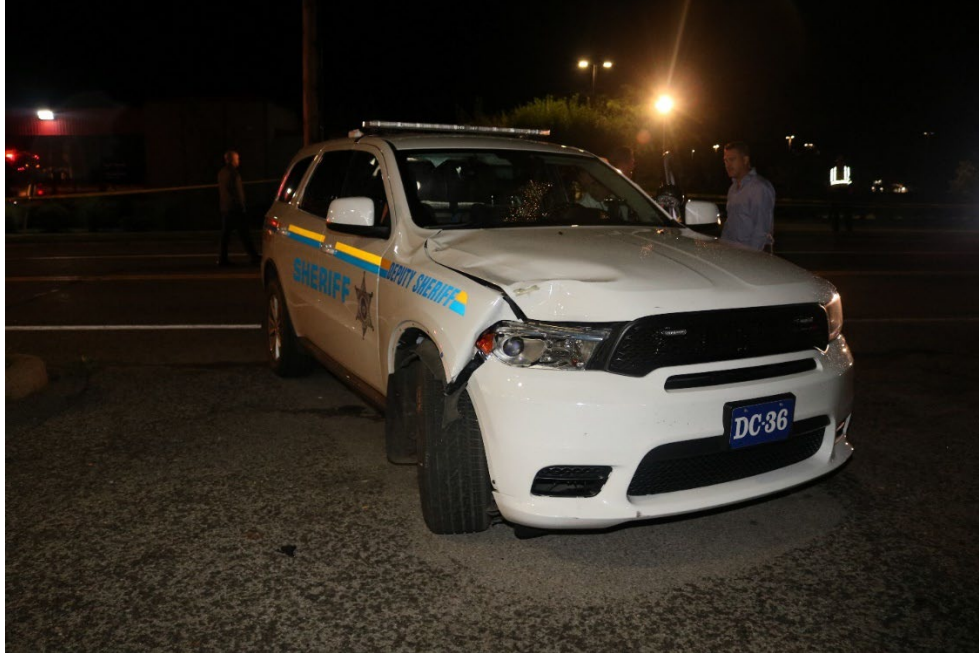
*Photo of Dep. Super's SUV showing damage on the passenger side front end.*

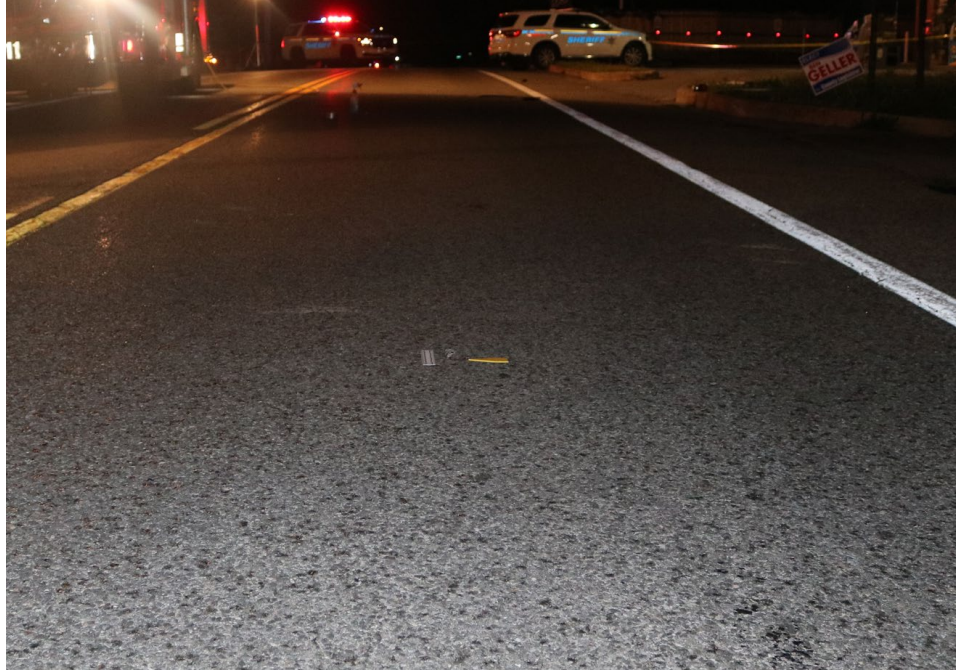
*Photograph of the white scuff mark in the middle of the southbound lane. The yellow arrow is pointing to the scuff mark.*

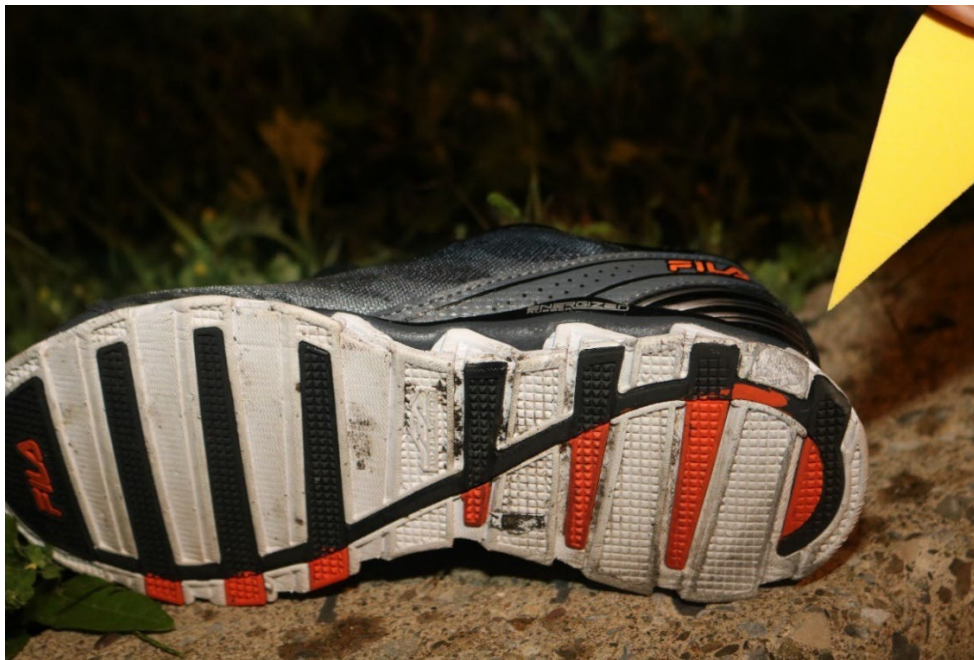
*Photograph of the sole of Mr. Domfeh's left shoe*
