Office of the New York State Attorney General Letitia James

Office of Special Investigation

Report on the Investigation into the Death of Zabina Gafoor

**DEATH OF ZABINA GAFOOR
FEBRUARY 17, 2023**

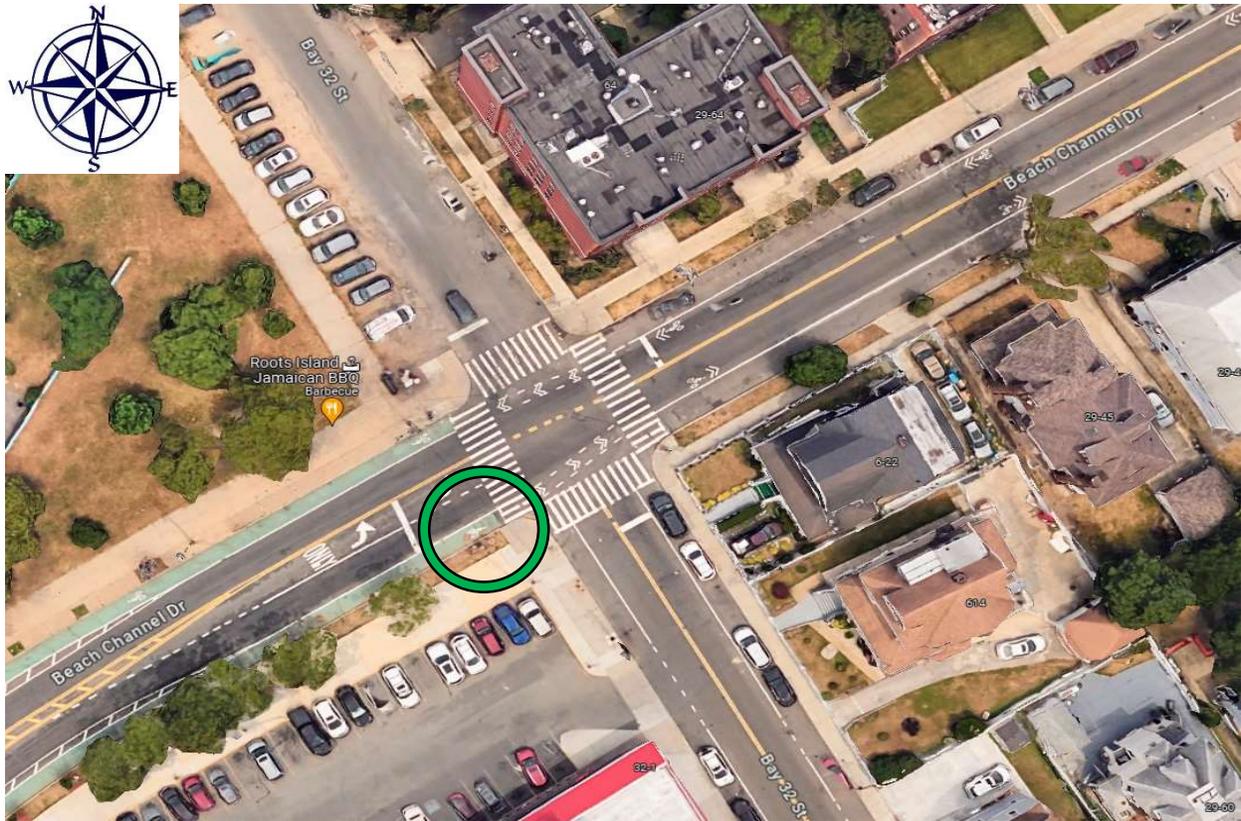
Google Maps aerial view of the intersection of Beach Channel Drive and Bay 32nd Street. The spot where Ms. Gafoor was standing just before the collision, in the bike lane, is circled in green. Before the collision, the police car was driving from the upper right toward the intersection (westbound) along Beach Channel Drive.

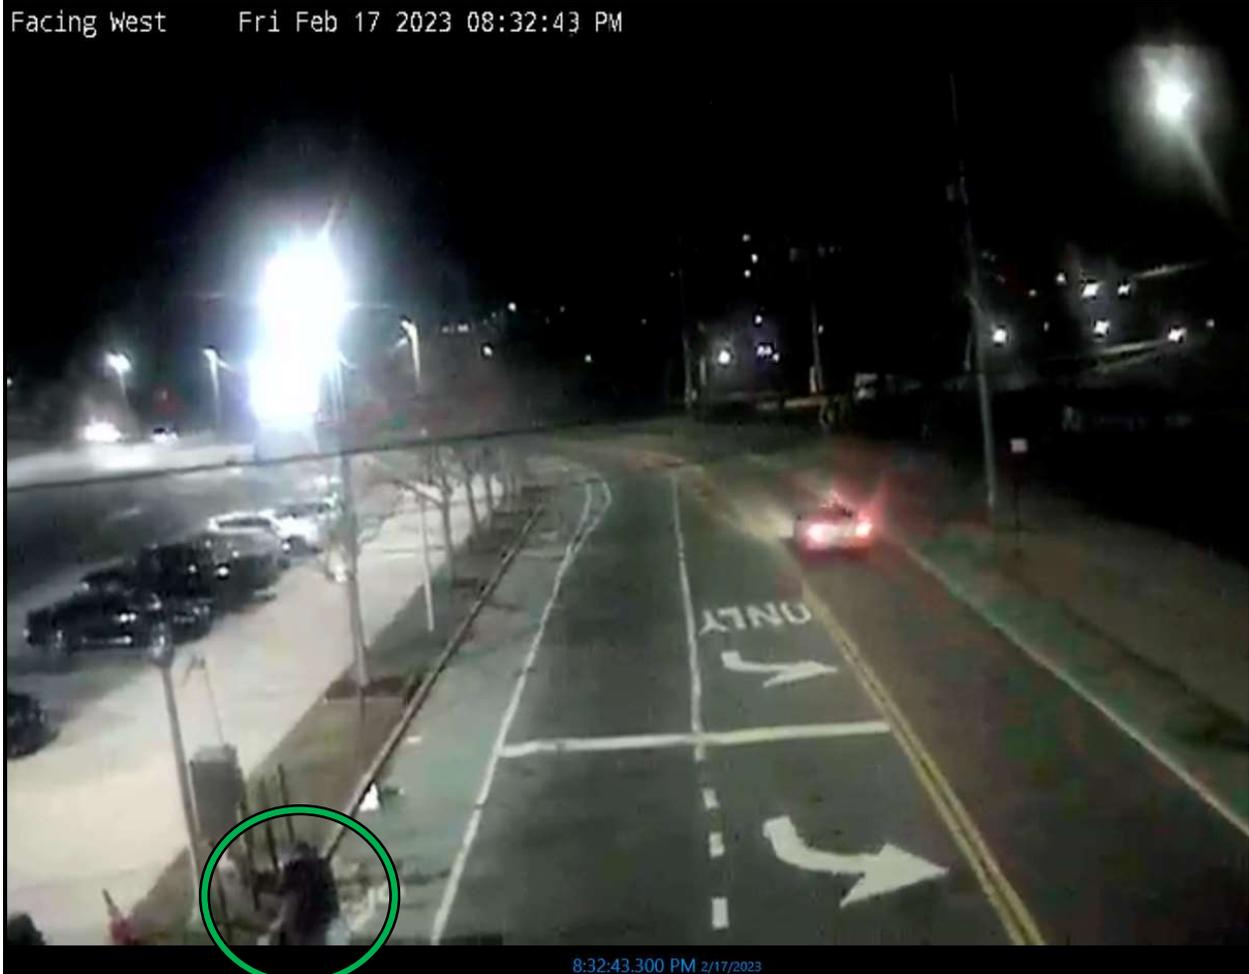
Still from a New York City Department of Transportation (DOT) camera, just before the collision, showing Ms. Gafoor standing in the bike lane (circled in green).

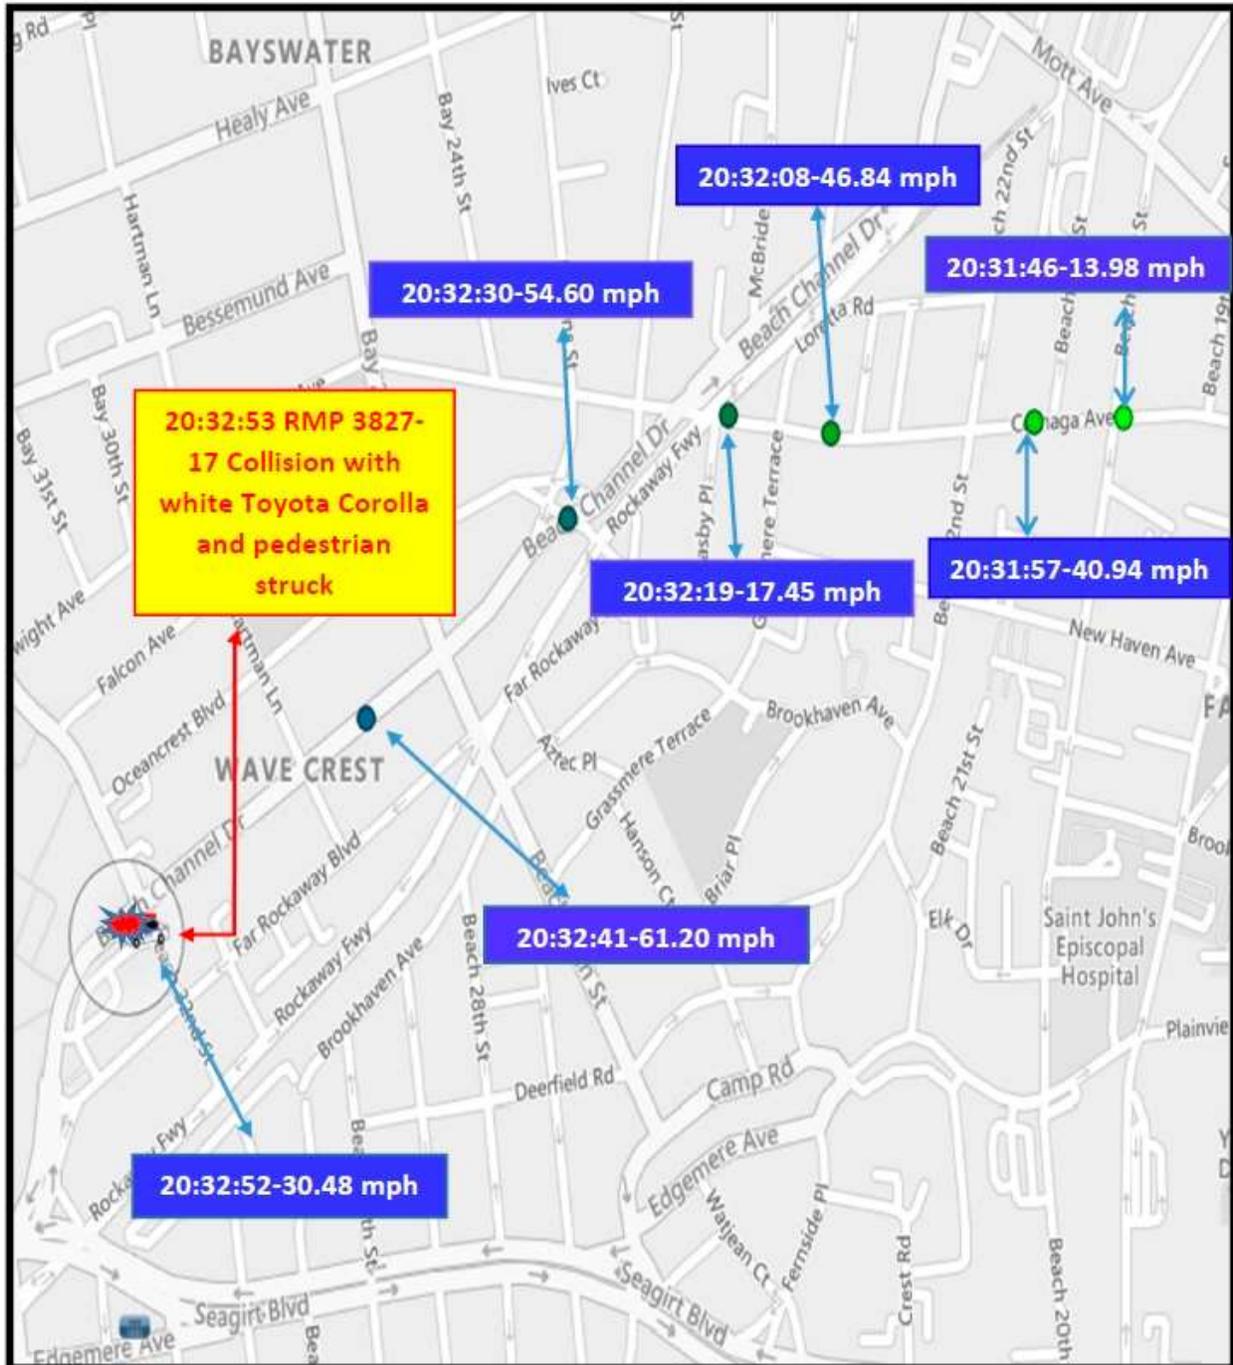
AVL map of Officer Osorio's route prior to the collision.

According to NYPD dispatch records, on February 17, 2023, at 8:30 p.m., officers radioed “10-85” (officer in need of additional units) for assistance in making an arrest at Beach Channel Drive and Beach 51st Street. Officer Osorio, in uniform and driving a marked RMP, responded with Officers Xavier Alvarado and Osvaldo Nunez and Detective Jacqueline Demerest. Officer Osorio left the 101st Precinct stationhouse and drove west on Cornaga Avenue and then southwest on Beach Channel Drive toward Beach 51st Street. The map of the route shown below is taken from NYPD’s Automated Vehicle Location (AVL) system, which shows the position and speed of police cars at 10-second intervals via information from GPS satellites.

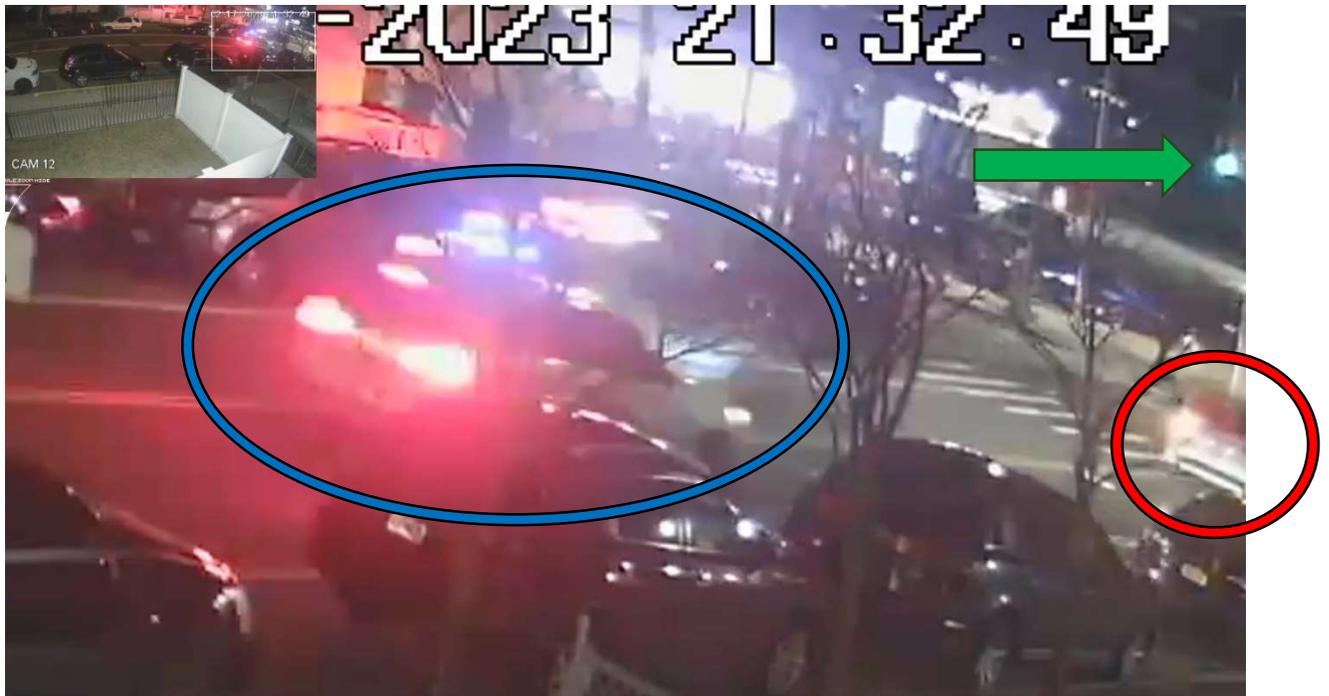
Zoomed-in still showing the traffic light was green (green arrow), at 8:32:49 p.m.

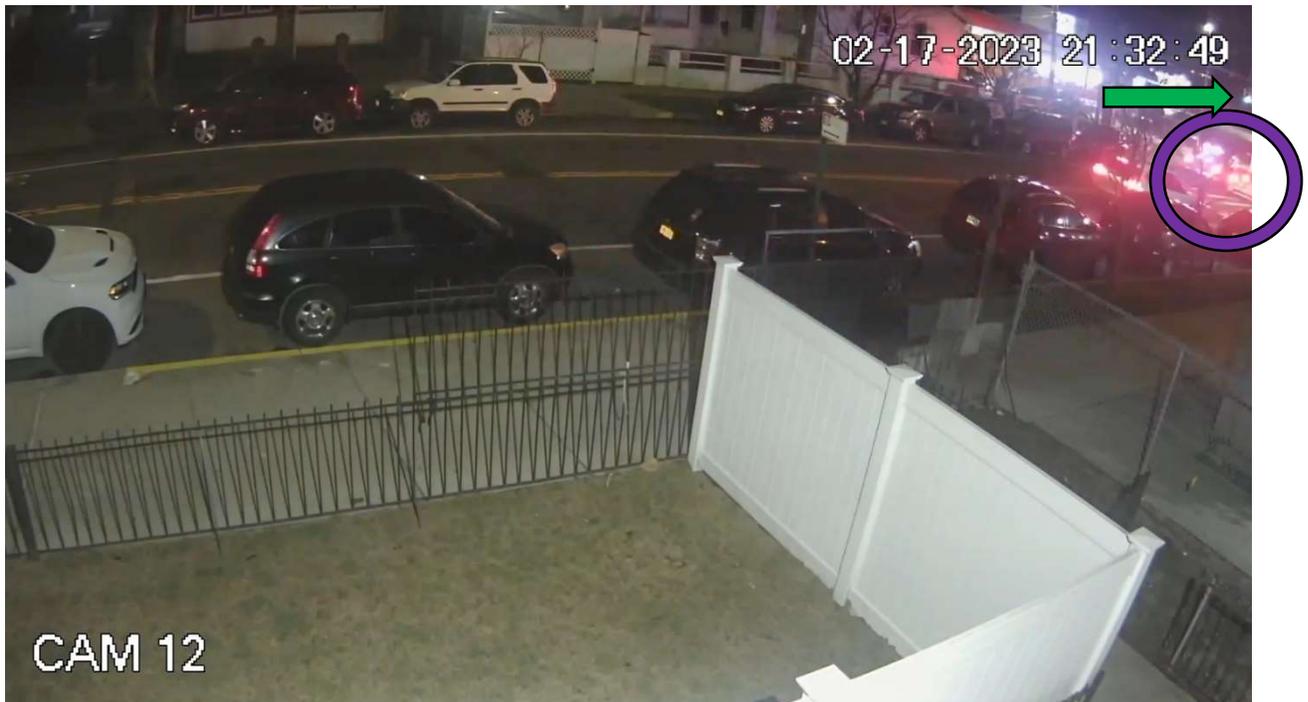
Still showing the police car colliding with the Toyota (circled in purple), at 8:32:49 p.m.

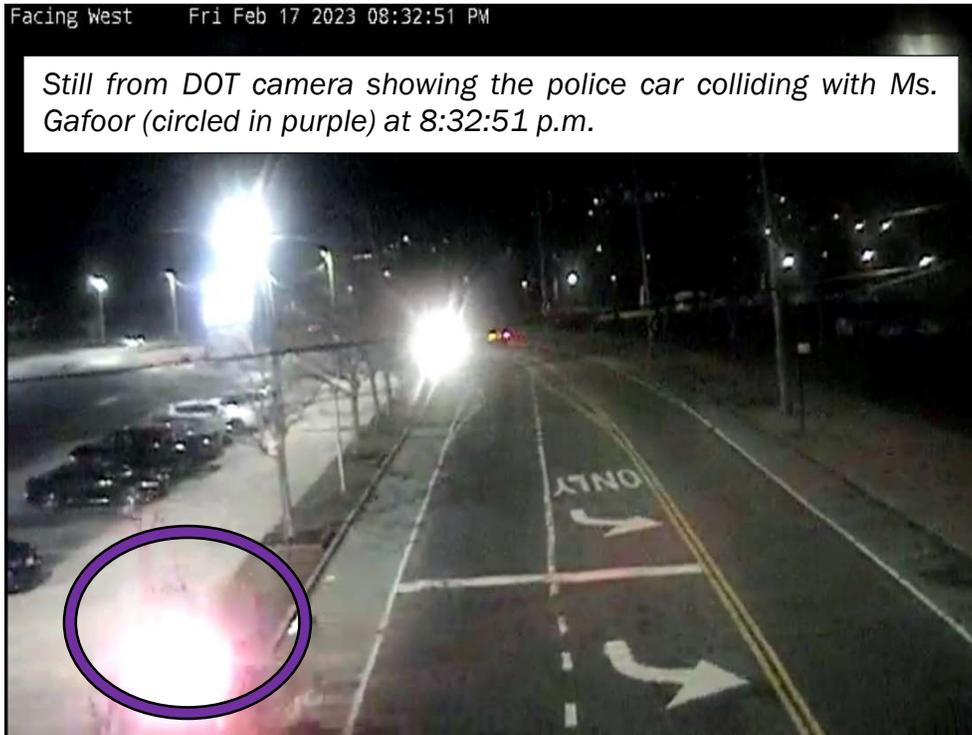
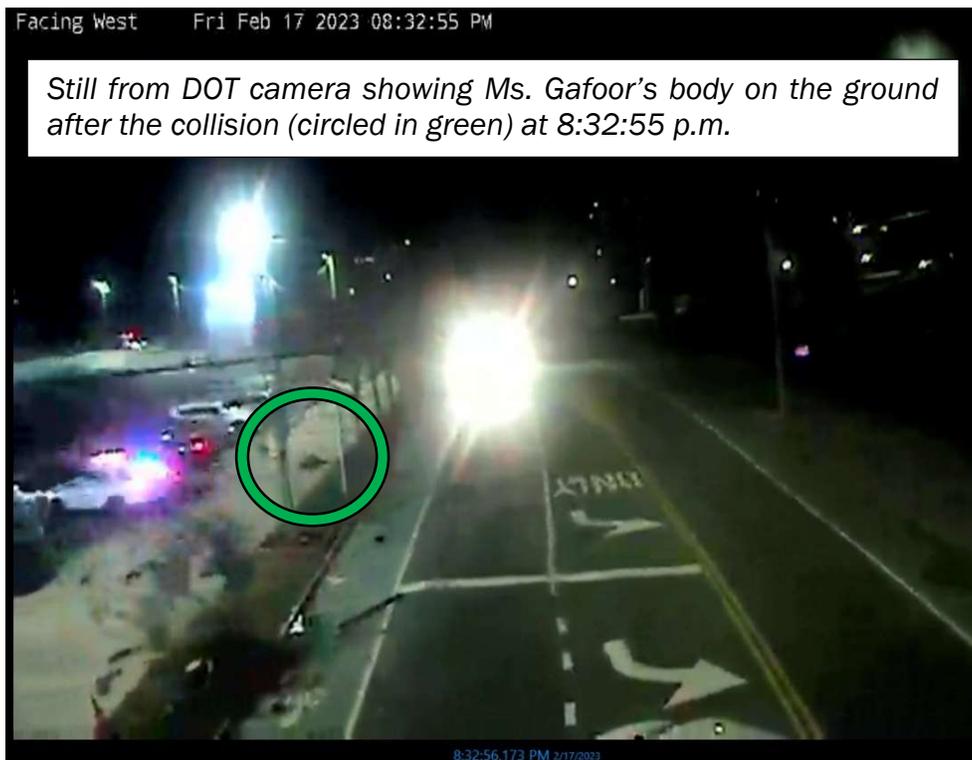
The DOT camera facing west at the intersection of Beach Channel Drive and Bay 32nd Street showed the collision. The video can be seen [here](#). Stills from the video are below:

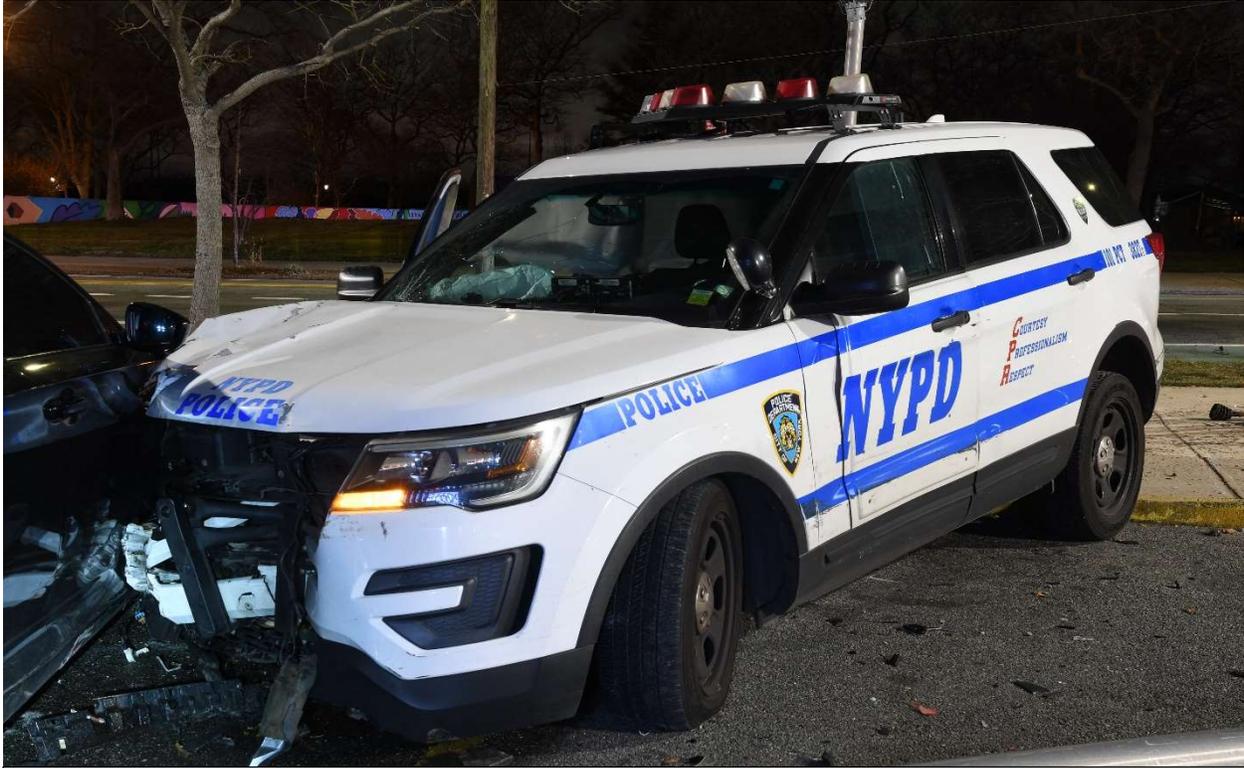
Among other responsibilities, NYPD’s Highway District investigates motor vehicle collisions through its Collision Technician Group (CTG) and Collision Investigation Squad (CIS). According to NYPD’s Intergraph Computer Aided Dispatch System report, at 8:46 p.m. a captain from the 101st Precinct asked CIS to respond to the collision; CIS arrived at 11:15 p.m. CTG officers photographed Officer Osorio’s RMP, which had side and front-end damage, as shown below:

CTG photograph of Officer Osorio's RMP.

Police Officer Edwards of CTG noted that the brake pedal pressure, taillights, brake lights, and windshield wipers of the police car could not be tested, and that the front windshield had collision damage. He further noted that the weather was “clear,” the lighting conditions were “dark-road lighted,” and the road condition was “dry.”
